Manhole Inspection Summary

Manhole # S07MM1037MH

Insp Date: **12/23/08 10:25 AM**

Location Address: **3324 GARRISON AVE**

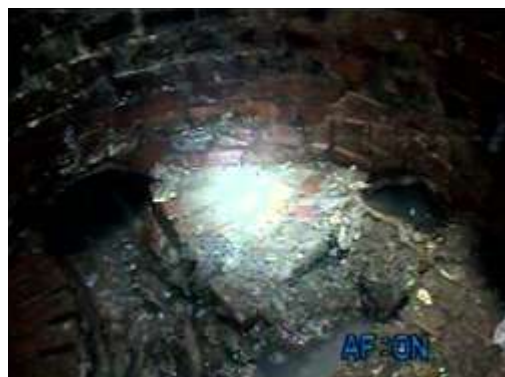
Defect 2

Condition: ☐ Sound ☐ Cracked ☐ Root Intrusion ☐ Deteriorated ☐ Leaks ☒ **Debris**

DEBRIS IN CHANNEL AND IN BENCH

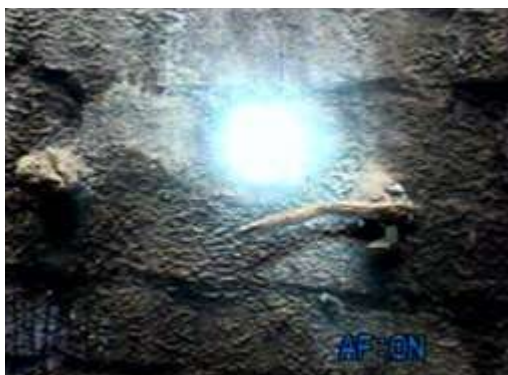
Defect 1

Count: **8** Missing: **2** ☒ **Corroded**

CORRODED/ MISSING RUNG

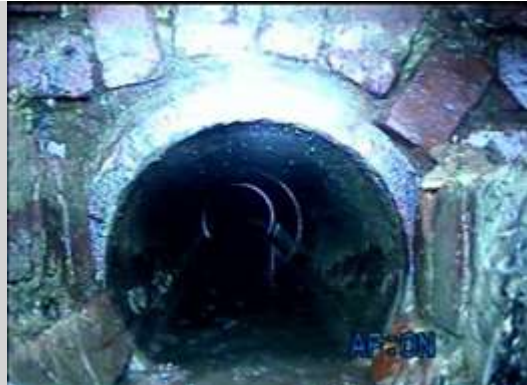
12 O'Clock Outflow

10 in. Circular Gravity Sewer
Pipe Out @ 12 O'Clock

Pipe Height: 6 (in.) Rod and Bar
Pipe Material: **Clay** ☐ Pipe Lined
Invert Depth: 14.90 (ft.) Flow Characteristics: **Slow**
Deposits: ☒ None ☐ Mud ☐ Sludge ☐ Debris ☐ Grease
Silt Depth: (in.) Deposits Extent:
Infiltration: **None** Pipe Seal Cond: **Sound**

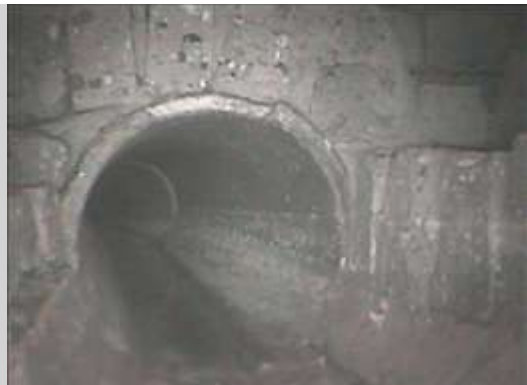
3 O'Clock Inflow

8 in. Circular Gravity Sewer
Pipe In @ 3 O'Clock

Pipe Height: (in.) Direct
Pipe Material: **Clay** ☐ Pipe Lined
Invert Depth: 14.47 (ft.) Flow Characteristics: **Slow**
Deposits: ☐ None ☐ Mud ☒ Sludge ☒ Debris ☒ Grease
Silt Depth: 7 (in.) Deposits Extent: **Heavy**
Infiltration: **None** Pipe Seal Cond: **Unknown**

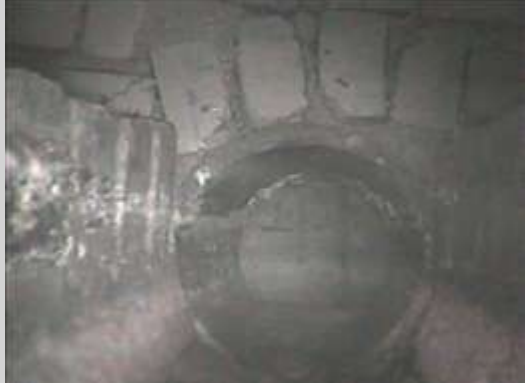
6 O'Clock Inflow

10 in. Circular Gravity Sewer

Pipe In @ 6 O'Clock

Pipe Height: **4.8** (in.) Rod and Bar

Invert Depth: **14.72** (ft.) Flow Characteristics: **None**

Deposits: ☒ None ☐ Mud ☐ Sludge ☐ Debris ☐ Grease

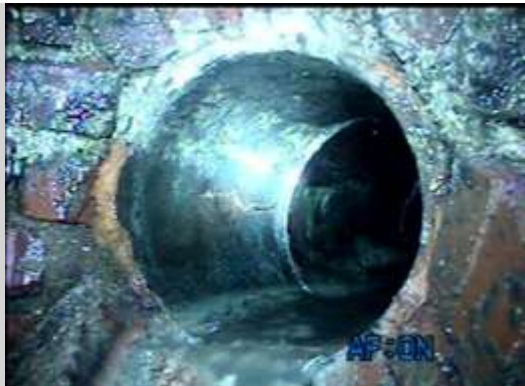
7 O'Clock Inflow

12 in. Circular Gravity Sewer

Pipe In @ 7 O'Clock

Pipe Height: **7.2** (in.) Rod and Bar

Invert Depth: **13.76** (ft.) Flow Characteristics: **Slow**

Deposits: ☒ None ☐ Mud ☐ Sludge ☐ Debris ☐ Grease
